Manhole Inspection Summary

Manhole # S31S1_033MH

Insp Date: **2/18/08 9:33 AM**

Location Address: **3520 Spelman Road**

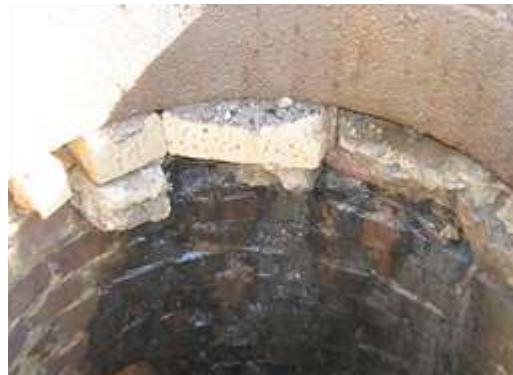
Defect 2

Condition: ☐ Sound ☐ Cracked ☐ Root Intrusion ☒ **Loose Brick** ☐ Deteriorated

Infiltration: ☐ None ☒ **Joint** ☒ **Cracks** ☐ Mortar ☐ Roots ☒ **Wall**

Chimney

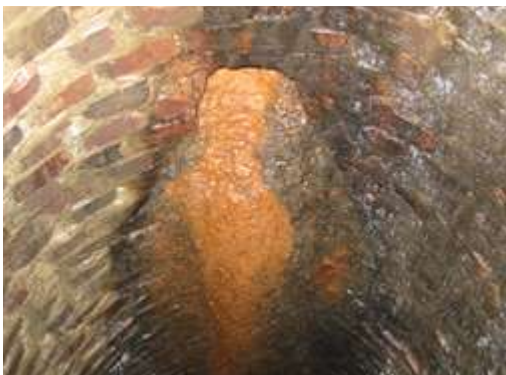
Defect 1

Infiltration: ☐ None ☐ Joint ☒ **Cracks** ☐ Mortar ☐ Roots ☒ **Wall**

Infiltration

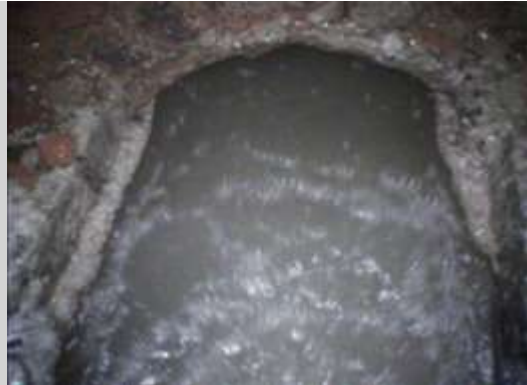
12 O'Clock Outflow

18 in. Circular Gravity Sewer
Pipe Out @ 12 O'Clock

Pipe Height: **18** (in.) Rod and Bar (Angled)
Pipe Material: **Clay** ☐ Pipe Lined
Invert Depth: **16.82** (ft.) Flow Characteristics: **Fast**
Deposits: ☒ None ☐ Mud ☐ Sludge ☐ Debris ☐ Grease
Silt Depth: (in.) Deposits Extent:
Infiltration: **None** Pipe Seal Cond: **Sound**

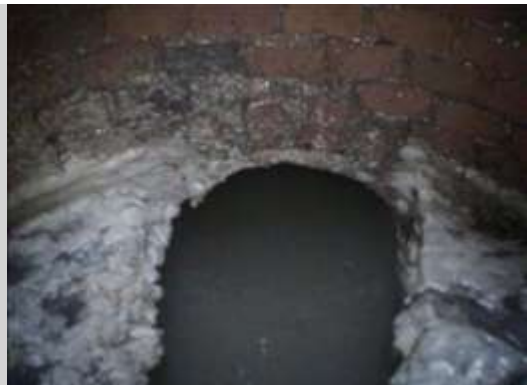
5 O'Clock Inflow

15 in. Circular Gravity Sewer
Pipe In @ 5 O'Clock

Pipe Height: **14.4** (in.) Rod and Bar (Angled)
Pipe Material: **Clay** ☐ Pipe Lined
Invert Depth: **16.57** (ft.) Flow Characteristics: **Fast**
Deposits: ☒ None ☐ Mud ☐ Sludge ☐ Debris ☐ Grease
Silt Depth: (in.) Deposits Extent:
Infiltration: **None** Pipe Seal Cond: **Sound**

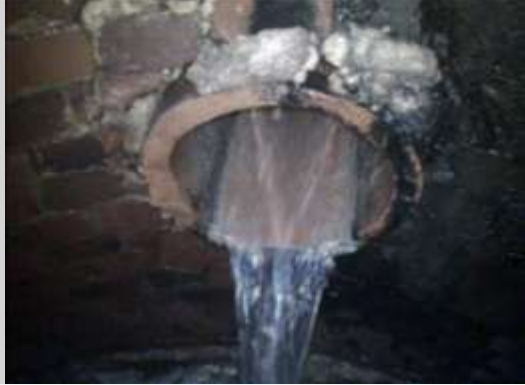
7 O'Clock Inflow

8 in. Circular Gravity Sewer

Pipe In @ 7 O'Clock

Pipe Height: **9.6** (in.) Rod and Bar (Angled)

Infiltration: **None** Pipe Seal Cond: **Sound**
